**Restoration plan for the Little River mangrove ecosystem: guiding early-stage restoration
through diagnostic assessment**

Trabajo de grado para optar al título de

Magíster en Restauración Ecológica

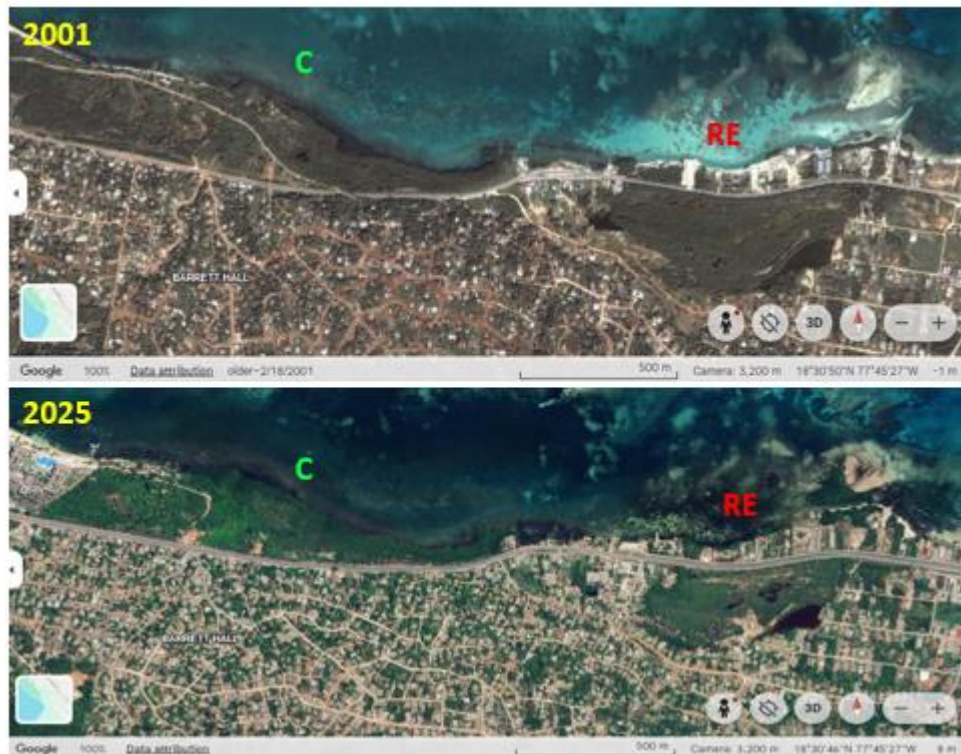
Figure 1. Comparative images of the Little River community showing land use change between 2001 and 2025. Source: Google Earth Pro v7.3 (2025).

The mangrove ecosystem at Little River, St. James, Jamaica, is under increasing threat due to a combination of human-induced pressures and altered environmental conditions, especially land reclamation over the past two decades (Fig.1).

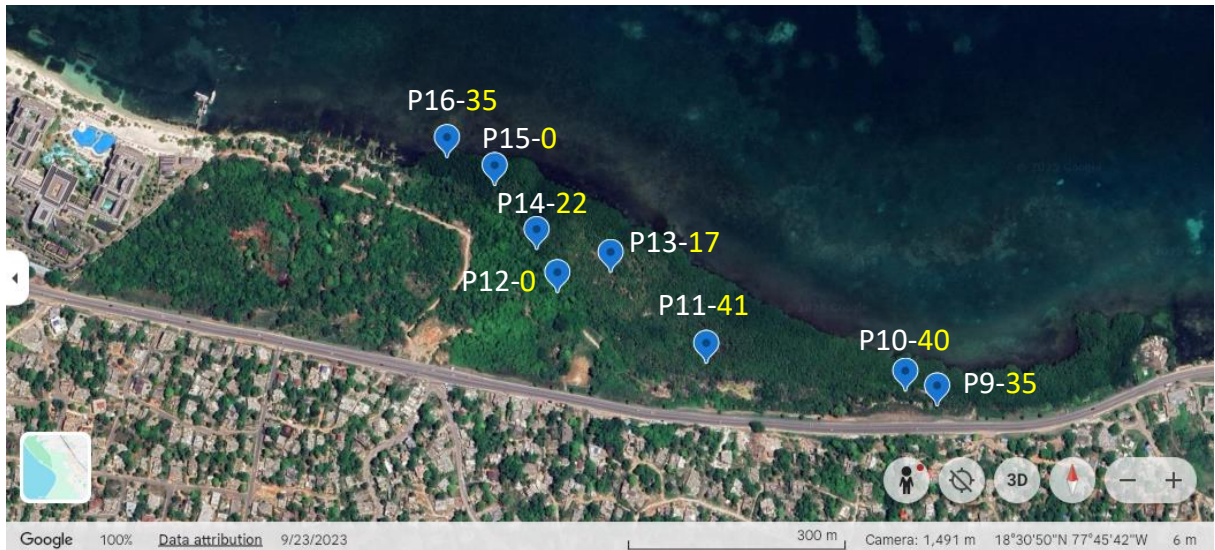
Figure 6. Spatial distribution of plots (blue points and white text) and salinity (yellow text) across the control site of the Little River community. Data are shown as: plot number- salinity (ppt). Source: Google Earth Pro v7.3 (2025).

During the dry season (January 2025), only water salinity was measured once per plot using a plastic 10ml pipette and a refractometer, but only when water holes were present in plot (Fig. 6 and Fig. 7).

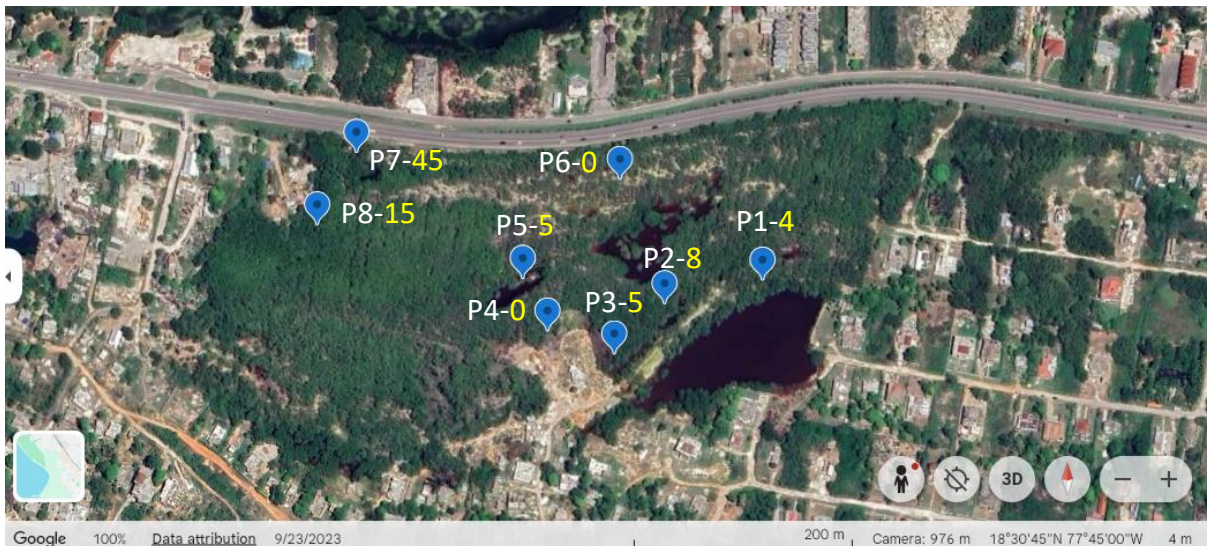
Figure 7. Spatial distribution of plots (blue points and white text) and salinity (yellow text) across the degraded/restoration site of the Little River community. Data are shown as: plot number- salinity (ppt). Source: Google Earth Pro v7.3 (2025).

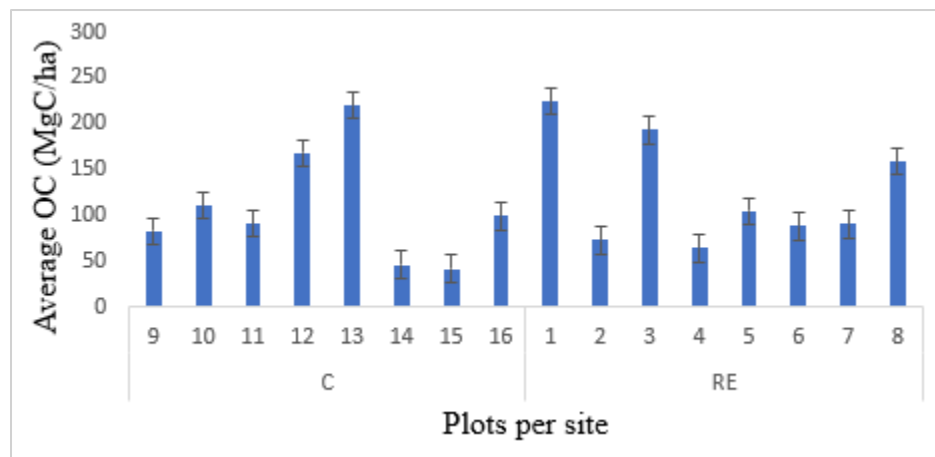
Figure 14. Comparison of organic carbon content (Mg/ha) between degraded/ restoration (RE) and control plots (C).

Underground organic carbon content (OC) was assessed to evaluate the carbon storage potential of both the control and restoration/degraded mangrove plots. Average values ranged from 41.26 to 219.57 MgC/ha, with degraded/restoration plots showing slightly higher average storage (124.3 Mg C/ha) compared to control plots (107 Mg C/ha) (Fig. 14). Notable variability was observed among individual plots.

Soils across both sites exhibited moderate to high organic matter content, with a mean loss-on-ignition (LOI) of 31.9 ± 24.4 (mean \pm SD) and an average organic carbon content of 18.5%. Soil carbon density averaged 0.072 g C/cm^2 , falling within the moderate range ($0.05\text{-}0.1 \text{ g C/cm}^2$). No significant differences were found between sites for bulk density (BD) ($U=247$, $p=0.82$) or carbon density (CD) ($t(47) = 0.86$, $p=0.42$). Total soil carbon stocks were estimated at 1,561 Mg C for the degraded/restoration site and 1,026 Mg C for the control site (Table 2).

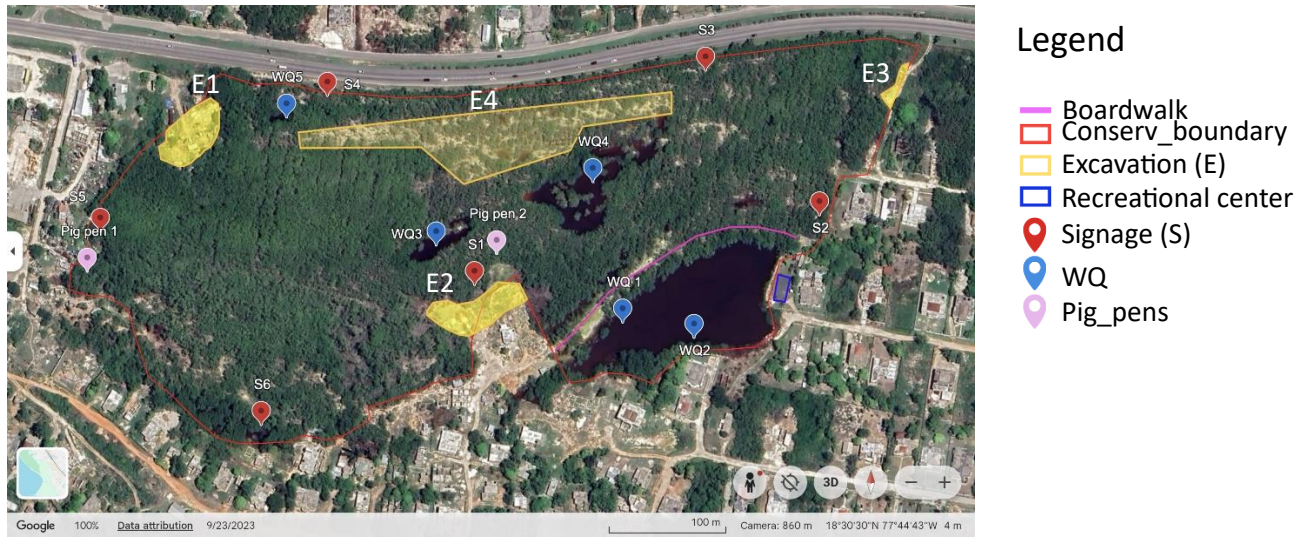
Figure 15. Intervention zones of the Little River mangrove restoration plan (2025-2050).

The total estimated volume of material to be excavated is 10,013.911m³, with off-site disposal recommended (see Fig. 15 and Table 3).
